Initial Misdiagnosis of a Traumatic Ceramic Femoral Head Fracture

A destructive ceramic head fracture was diagnosed 1 year after a serious motorcycle accident in a patient who had undergone primary THA 7 years earlier.

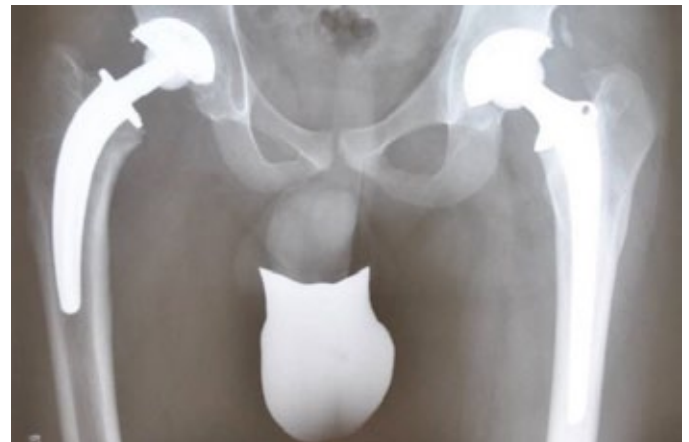
Figure 1. Anteroposterior pelvic radiograph (24-year-old male) after primary THA for secondary osteoarthritis due to Perthes disease (right hip: cementless CFP stem and TOP acetabular cup; left hip: hybrid THA with cemented ENDO Mark III stem + cementless TOP acetabular cup; Waldemar Link GmbH, Hamburg, Germany).

less THA of the right hip 1 year later at our institution (Figure 1).

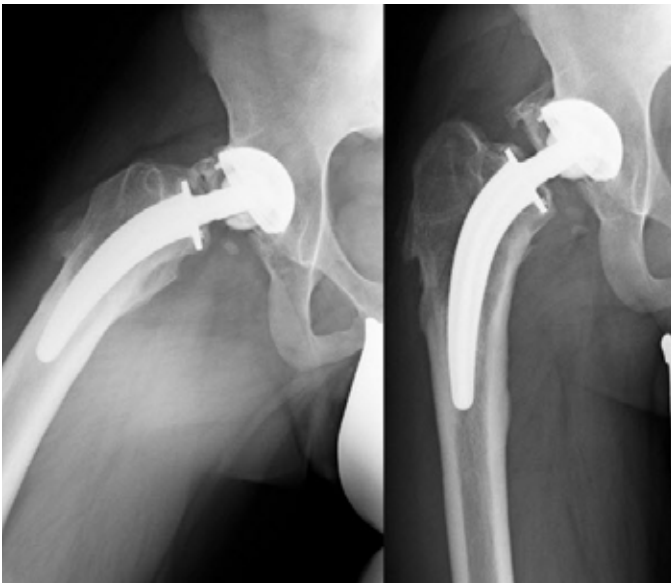
Figure 2. Conventional pelvic radiographs directly after trauma, revealing ceramic head fracture.

Although initial anteroposterior radiographs of the pelvis and right hip axial views were performed, no signs of fractures, aseptic loosening, or implant damage were diagnosed by the attending trauma surgeons (Figure 2). Two weeks after surgical treatment of the ankle fracture, the patient noticed a sudden “cracking” sound in his right hip, as well as shortening of the right lower limb. Interestingly, the patient had no relevant pain.

Although a relatively rare complication in modern THA, the described ceramic head fracture was misinterpreted in initial radiographs, which showed a discreet fracture of the ceramic head. Two assumptions

can be made which led to this misdiagnosis. Firstly, the complex ankle fracture was probably more painful than the ceramic head fracture and this misled the surgeons. Secondly, although the initial radiographs revealed a ceramic head fracture, the staff at the initial center of admission did not have the training necessary to reach the correct diagnosis.

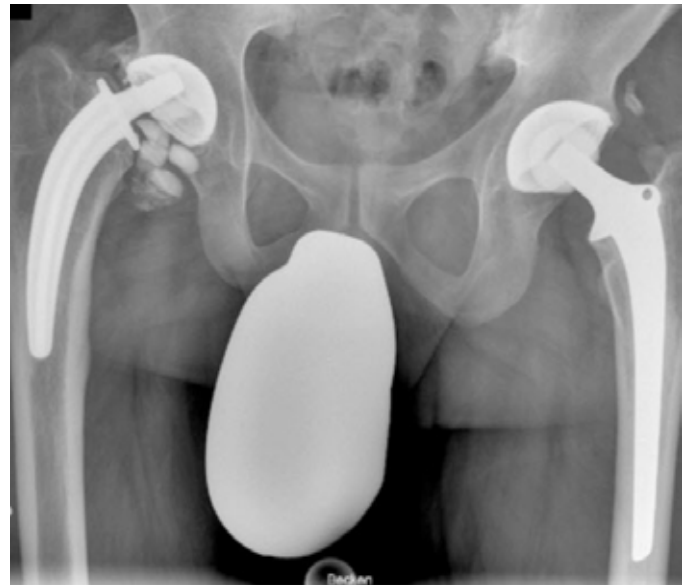
Further conventional radiographs, in two planes, more than a year after the initial radiographs, revealed a completely destroyed, multi-fragmented ceramic head (Figure 3).

Figure 3. Anteroposterior pelvic radiograph 8 months after the initial radiographs, showing a fractured ceramic head.

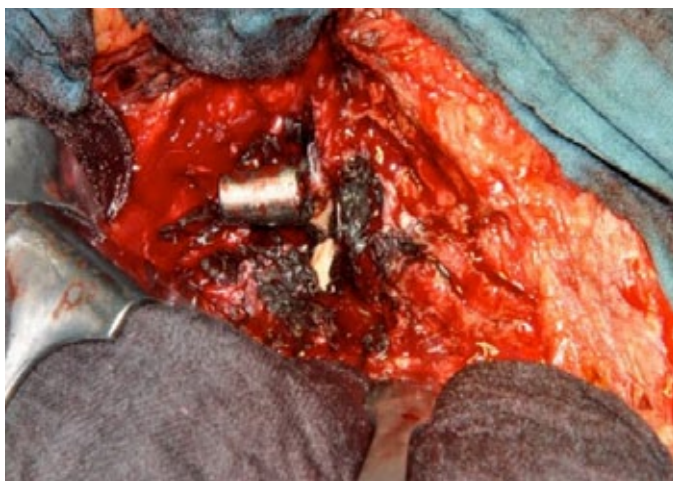
Intraoperatively, extensive damage of the ceramic head and correlating taper junction of the femoral neck was found (Figures 4-6). Concomitantly, there was severe debris-related metallosis throughout the entire joint (Figure 7).

Figure 4. Intra-operative image showing countless debris and the damaged taper junction of the femoral neck (in situ).

The intervention consisted of conversion of the short cementless CFP stem to a cementless revision stem and an acetabular cup revision to a ceramic-ceramic bearing surface (Alloclassic stem and Allofit-IT acetabulum with Delta Ceramic Inlay, Zimmer, Warsaw, Indiana, USA, and CeramTec, Plochingen, Germany).

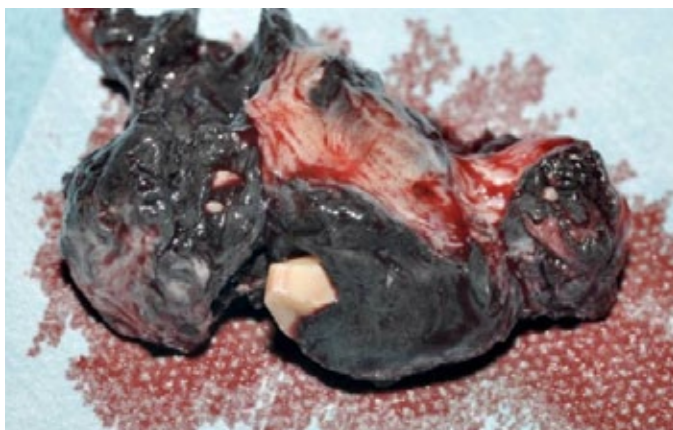
Figure 5. Intra-operative image showing the fragmentation of the ceramic head.

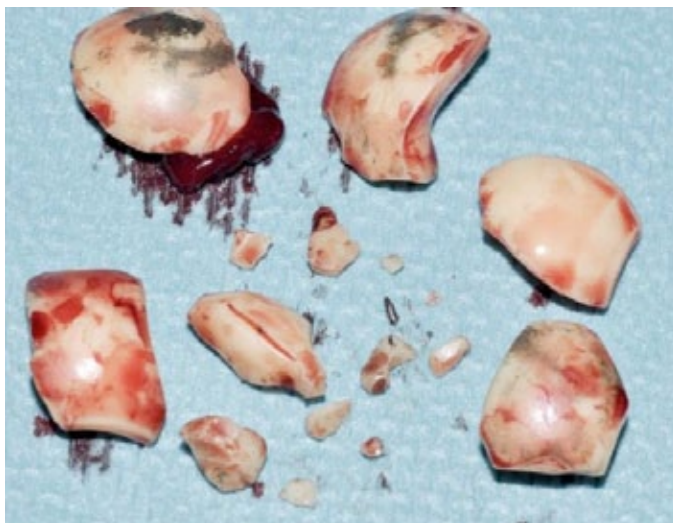
Figure 6. Image showing the explanted components: a fragmented ceramic head, a damaged stem, and acetabular cup and liner.

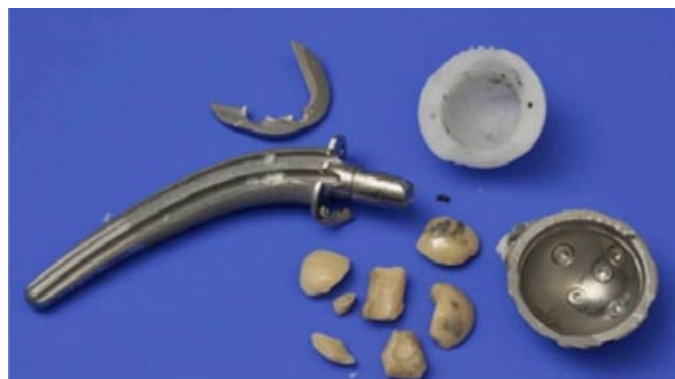
Figure 7. Intra-operative image showing debris with ceramic fragments.

Meticulous debridement of all affected soft tissues and extensive lavage were also performed.

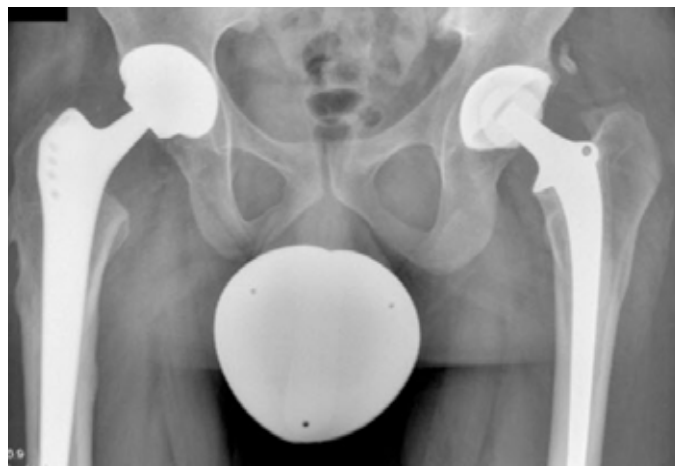
The postoperative course was uneventful, with radiographs revealing a correct position and articulation of the cementless implant (Figure 8).

Figure 8. Postoperative anteroposterior pelvic radiograph.
