A Rare Dissociation at the Neck–Stem Interface

The authors report a case of dissociation at the neck–stem interface without hip dislocation that occurred during walking, and discuss strategies to avoid and treat this complication of THA.

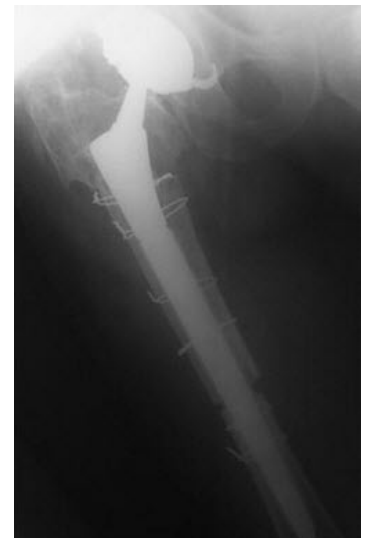
Figure 1. Radiograph after the first operation reveals good relationship of the total hip prosthesis with acetabular and femoral bones.

Postoperative radiographs revealed adequate positioning of the THA components (Figure 1). The usual protocol for THA postoperative treatment was used, and patient mobilization began on the second postoperative day. The patient was discharged on the eighth postoperative day, fully mobilized (partial weight-bearing) and without residual problems.

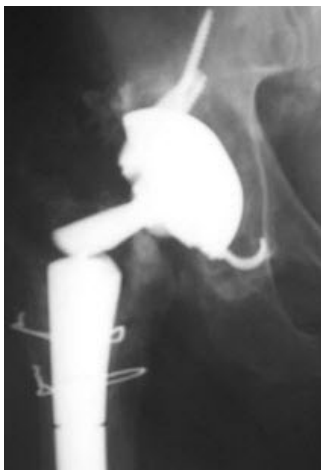
One month later (4 months postoperative), the patient arrived at our emergency department unable to walk and with pain in the revised hip. At clinical presentation, he reported an incident of sudden pain and then falling during normal walking and with no extreme hip movement or rotation. Radiographs revealed dissociation of the modular stem at the femoral neck–stem interface without dislocation of the head (Figure 2).

Figure 2. Radiograph shows dissociation of the femoral neck–stem interface.

Immediate revision surgery was performed to re-affix the neck to the main body of the prosthesis. During the operation, stability testing of the acetabular shell revealed adequate fixation of the prosthesis. A new modular interchangeable neck system was implanted; however, as this type of stem also has a modular proximal component, we decided to change it to prevent further complication at the proximal component–stem junction.

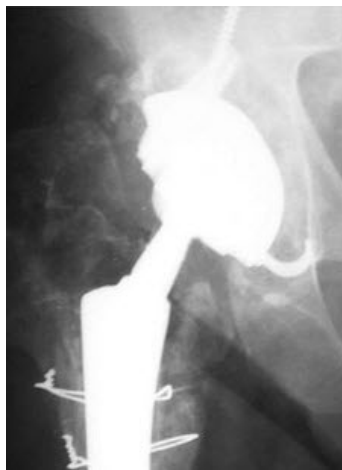
Figure 3. Radiograph after the second operation reveals reimpacted new femoral neck–stem component. Notice the absence of ectopic bone from the lesser trochanter area.

All intraoperative stability and orientation tests were normal. Postoperative radiographs were normal (Figure 3).

Intraoperatively, during the second revision, a large amount of ectopic bone was found in the lesser trochanter area, which is a possible cause of stem impingement and, in particular, the neck–stem interface, which may lead to dissociation due to repetitive stresses and micromovement in the area. The ectopic bone was removed, and intraoperative mobilization revealed free movement of the hip joint in all pos-

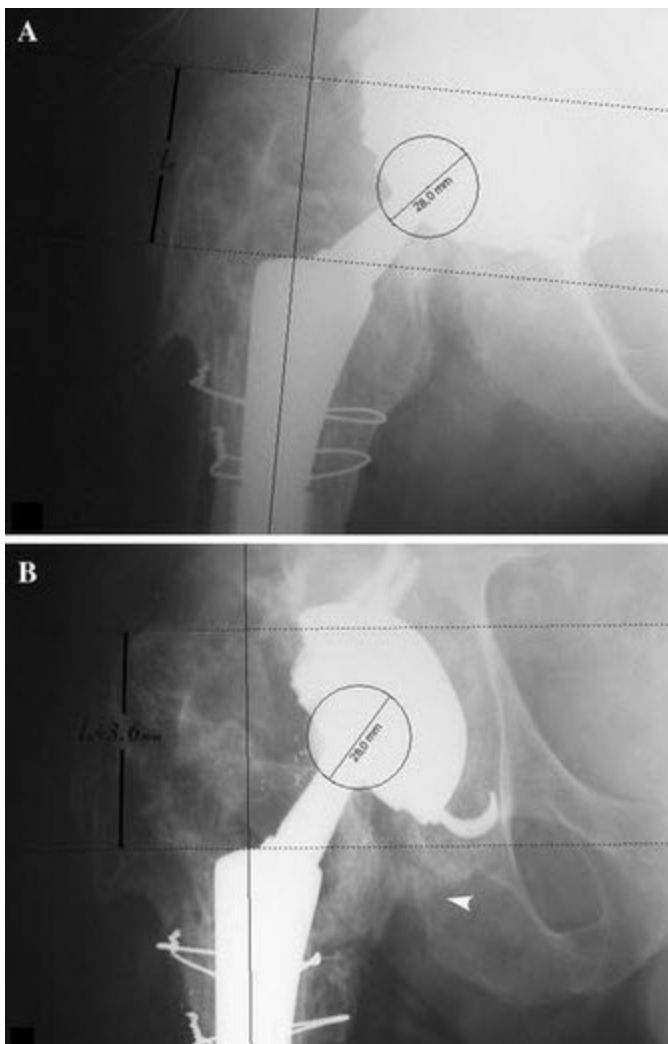
Excessive telescopic movements, which finally led to dissociation by creating negative pressure in the acetabular area. Computer-assisted measurement of distal stem migration showed a subsidence of 3.6 mm at 3 months, which is considered excessive for this short postoperative period, though it is expected for this type of revision stem and transfemoral approach [14] (Figure 4).

Figure 4. Stem subsidence was measured by processing immediate postoperative (a) and 3-month (b) follow-up anteroposterior radiographs via Roman v1.7 software (Roman free to share software version V1.70; Robert Jones and Agnes Hunt Orthopaedic Hospital, Oswestry, UK; <http://www.Keele.ac.uk/depts./rjah/>), as a change in the vertical distance from the proximal tip of the greater trochanter to the shoulder of the stem. Ectopic bone formation at the lesser trochanter area (white arrowhead) is noted 3 months postoperatively (b).

Such an early stem subsidence and subsequent leg shortening can result in loss of intraoperative soft tissue tension and, eventually, in hip-joint instability.

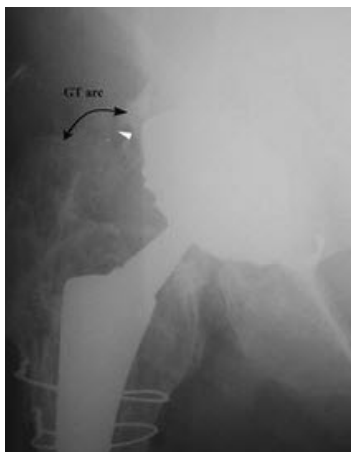
Figure 5. Minimal greater trochanter (GT) arc length and high position of the tip of the GT in relation to the head center predicts early impingement of the GT to the ilium. A bone spur (osteophyte) at the tip of the GT (white arrowhead) may further limit impingement-free range of motion.

mal arc length and the high position of the tip of the greater trochanter in relation to the head center predicts early bony impingement (greater trochanter to ilium) (Figure 5).
