# Tibial Stress Fracture After Computer-Navigated Total Knee Arthroplasty

In this case report, the patient experienced a stress fracture at one of the pinhole sites used for placement of the computer navigation system's tibial trackers.

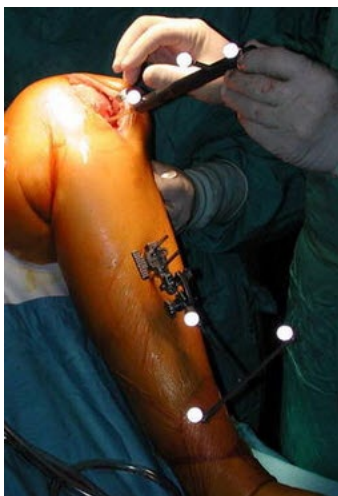
free navigation system (Ci™ navigation system, DePuy I-Orthopaedics, Munich, Germany) was used. To perform the electronic measurements, one bicortical navigation tracker (5 × 200 mm) was set at the distal part of the femur and two bicortical navigation trackers (4 × 130 mm) were set on the tibial diaphysis (Figure 1).

Figure 1. Trackers set on the tibial diaphysis.

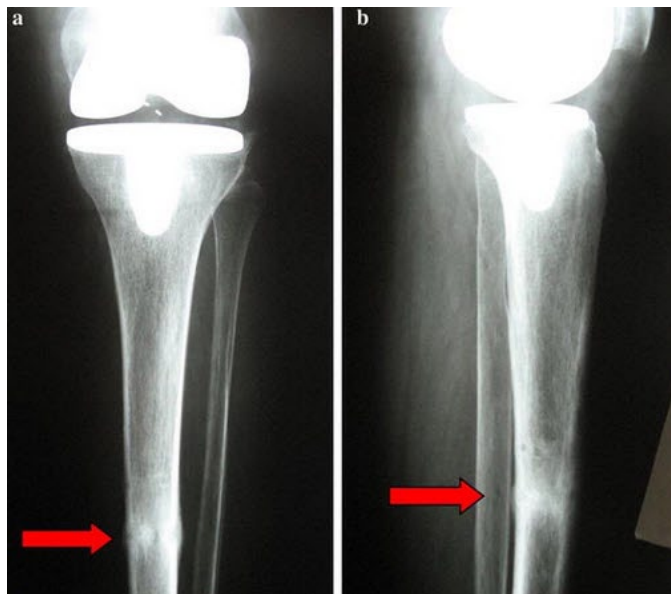
Figures 3a-b. a - AP X-ray: good healing of the tibial stress fracture. b - LL X-ray: good healing of the tibial stress fracture.

As a result, the patient wore a brace and was instructed to avoid weight-bearing for the following 4 weeks. After 4 weeks, she was allowed to gradually weight-bear with use of a leg cast for another 4 weeks. Subsequent X-rays at the 14th week showed good healing of the fracture (Figures 3a-b).

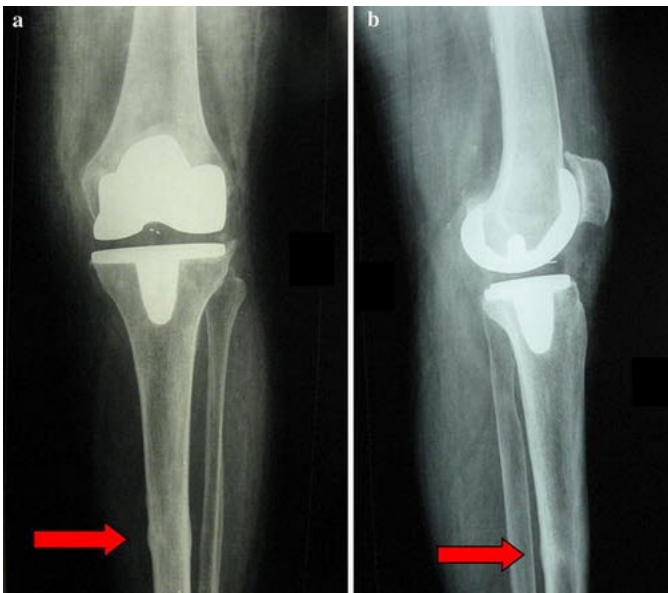
Radiologically, the stress fracture was completely healed and the left lower limb showed a good alignment (Figures 4a-b).

Figures 4a-b. a - 7-month follow-up AP X-ray: complete healing of the fracture. b - 7-month follow-up LL X-ray: complete healing of the fracture.
