CASE REPORT

Osteolysis with Ceramic on Highly Cross-linked Polyethylene

Joseph Fetto, MD[§]

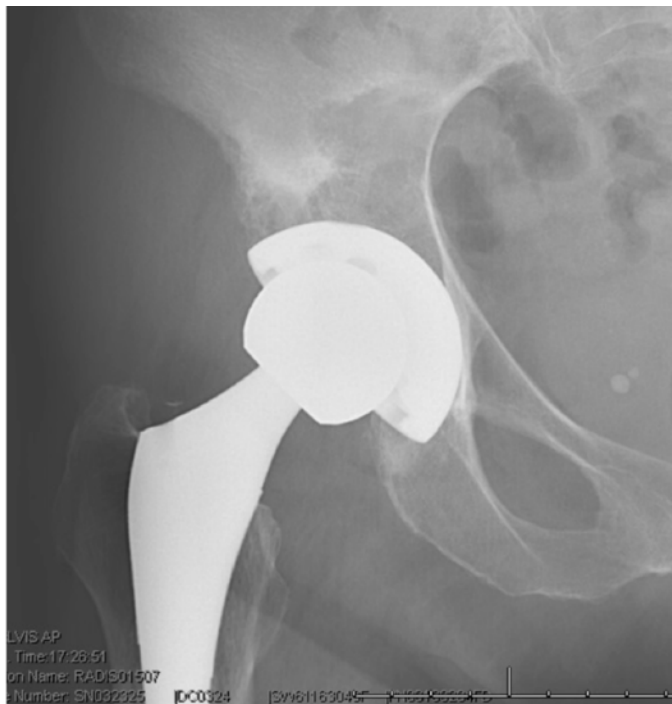
physical exam demonstrated a slender female in moderate discomfort with attempts to ambulate. Her internal/external rotation and ab/adduction in a seated position were unrestricted but produced groin/buttock pain at the end of range. Neuro-vascular examination of the lower extremities was unremarkable. Her x-rays demonstrated well positioned non-cemented components with asymmetrical positioning of the femoral head within the acetabular shell. There was a large osteolytic lesion in zones 1 and 2 over the right acetabulum. (Fig.1).

Figure 1. Pre-operative pelvic x-ray, 6 years S/P a right non-cemented ceramic on polyethylene THA. There is a large area of pelvic osteolysis in zones 1 and 2; osteolysis is also seen in the greater trochanter and femoral zones 1 and 7. There is asymmetrical positioning of the femoral head within the acetabular shell, implying polyethylene wear.

There was osteolysis within the greater trochanter, extending circumferentially into Gruen zones 1 and 7 about the femoral component. The white caseous material was found peripherally about the posterior, superior and anterior aspects of the acetabular component, from 8 o'clock to 4 o'clock. The component appeared to be osseously integrated in the lower, medial quadrant but demonstrated a rocking motion when pressure was applied to the superior margin of the cup. After explant of the cup, a large cavitory defect was exposed measuring 2x4x3 centimeters extending into the ilium and pubis. There was no defect in the medial or posterior-inferior walls.

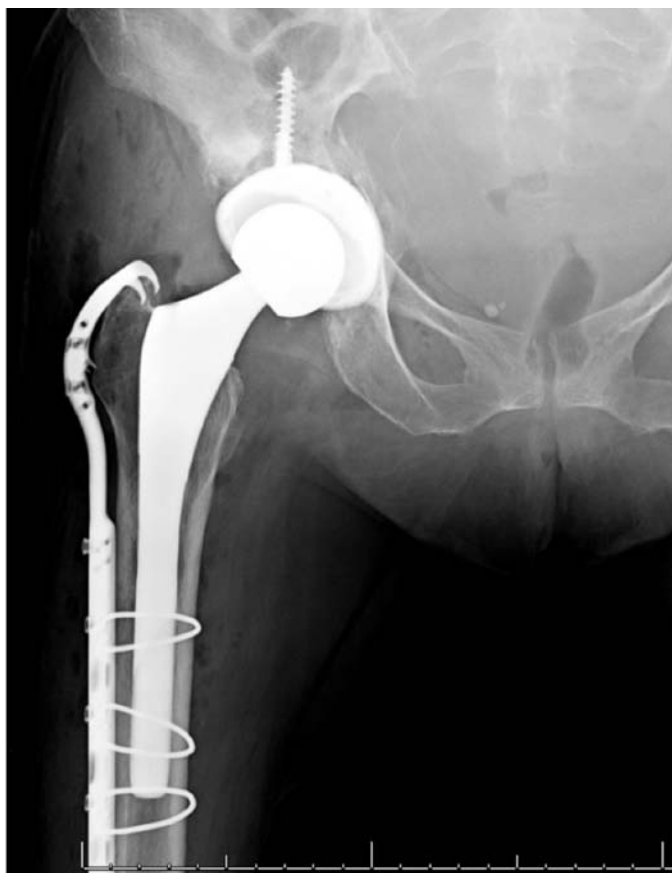
Figure 2. Post-operatively, the patient has been permitted toe-touch-partial weight bearing with a walker. She is now two months following her revision surgery, with resolved groin/buttock discomfort and no change in position of her acetabular component.

Fibrous tissue was gently curetted from the defect and the acetabulum reamed to accommodate a 54mm non-cemented component. Prior to implantation of the new acetabular component, the defect was filled with a mixture of ground cancellous chips and DBM paste. The acetabular preparation was completed by reverse reaming. Impaction of a flared rim cup provided modest "press-fit" fixation. This was supplemented with three 6.5mm cancellous screws. A non-hooded highly cross-linked, Vitamin E liner was gently impacted in place. With secure fixation of the acetabular component achieved, a 34mm ceramic head was fitted to the femoral component and the hip reduced without complication. (fig.2).
