A Novel Approach to Reduction of Wear In THA

By: Richard Treharne, PhD, MBA*, and Timothy McTighe, Dr. H.S. (hc)** **Hugh Cameron, M.B. Ch. B.*****

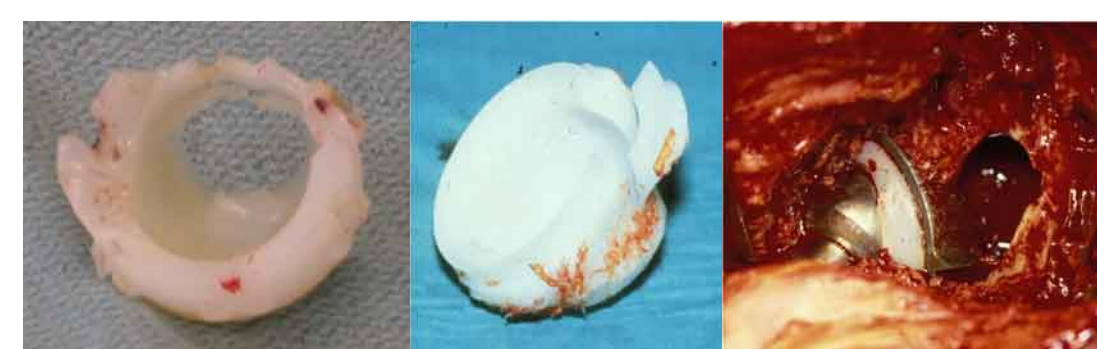
Poly Failure Leads to Revision Surgery

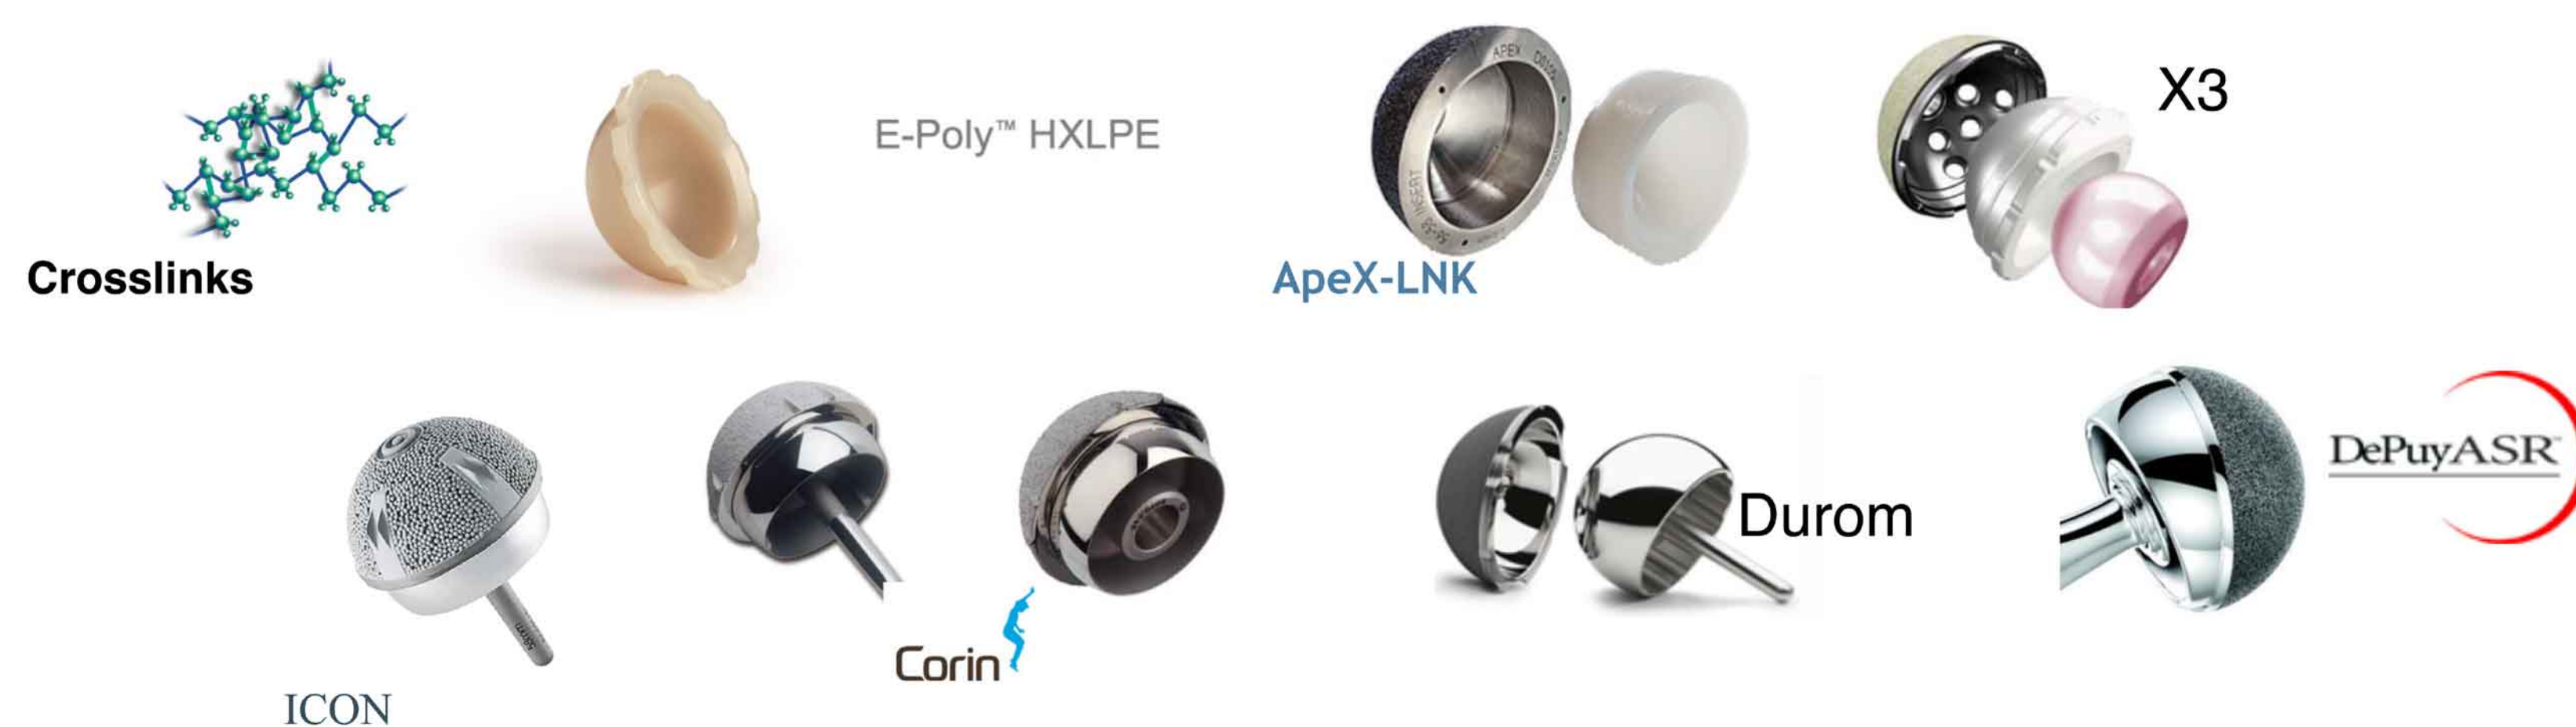
Two failed CrossLink (Longevity™)¹⁴

MOM Bone Necrosis - A. Toms

Cup spin out 7 weeks post-op. Revision made easier by proximal modular neck design.

Hypersensitivity to metals

Issues have been raised from squeaking to high trace elements, strength characteristics and torsional stability of current materials.^{3,4,5,6,7,8,9}

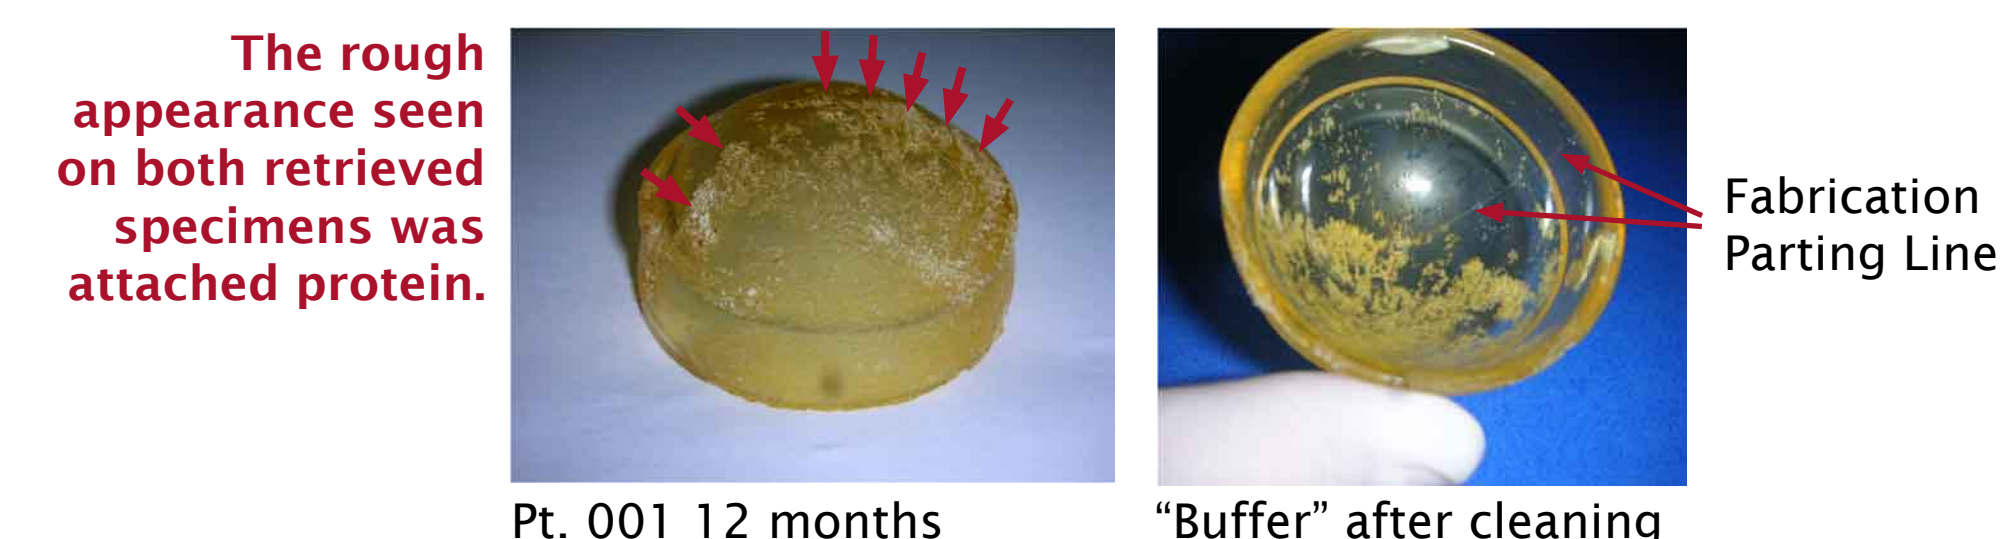
Pt. 001 12 months

"Buffer" after cleaning
