A NEW APPROACH TO BEARING SURFACES FOR TOTAL HIP ARTHROPLASTY

A POSTER EXHIBIT AT THE 1994 AAOS MEETING
NEW ORLEANS, LOUISIANA

INTRINSIC™ SEGMENTED CERAMIC CUP DESIGN

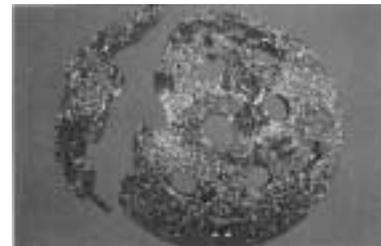
Fiber Mesh Cup

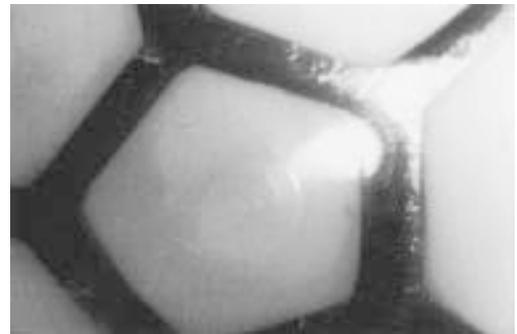
Hex Design Post-Test

Post-fatigue testing (10 million cycles) has demonstrated no significant mechanical failures of the grout material (polysulfone) or of the ceramic bearing. SEM evaluations did demonstrate a small micro fracture within the grout and a polishing effect on the ceramic bearing surface.

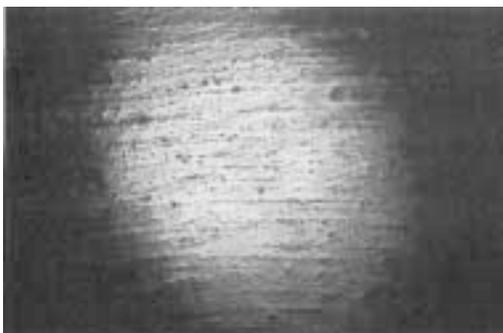
500X Pre-Test

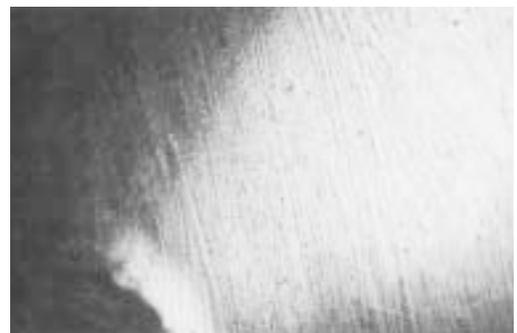
500X Post-Test

This test suggests that the bearing surface might benefit from pre-cycling to reduce initial ceramic debris.

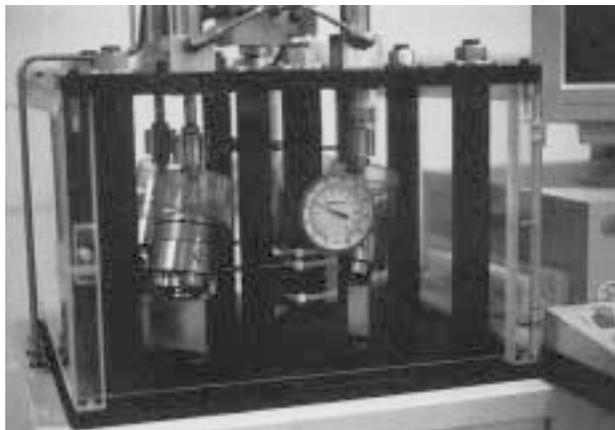
P.M. Wear Tester

Ongoing wear testing comparing different grout materials (peek and poly) on a P.M. state-of-the-art wear tester in conjunction with contact area and finite element analysis studies will help to determine the value of this design.
