Trunnion Corrosion and Early Failure in Monolithic Metal-on-Polyethylene TMZF Femoral Components: A Case Series

Abstract

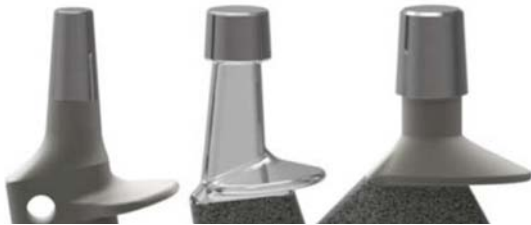
Image 1: Illustration Showing Different Taper Designs by Manufactures. (Courtesy of Chris Burgess, Signature Orthopaedics Ltd.)

Modularity in total hip arthroplasty (THA) design was introduced more than 30 years ago [1,2]. Potential benefits included a greater intraoperative flexibility to adjust leg length, offset and stability, ease of component revision and decreasing overall prosthetic inventory. Modular head-neck tapers vary in their geometry, size, conical angle, finish and metallurgy. An extensive number of tapers are available across the many device manufacturers (Image 1) [3]. The effect of taper length and diameter on the potential for corrosion is controversial. A shorter trunnion length reduces the available taper surface area for interference fit and therefore may predispose to micro motion whereas a longer trunnion with wider taper angle may contribute to mechanically assisted crevice corrosion (MACC) [4,5].

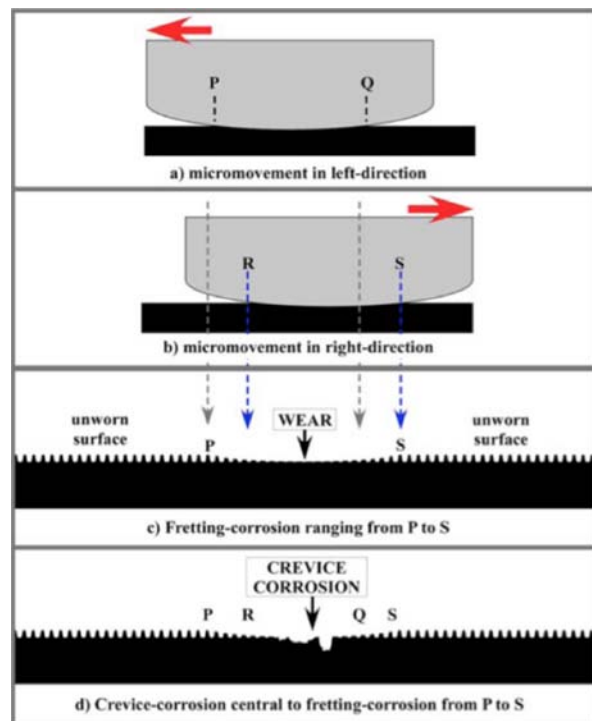
Image 2: Schematic illustrating that oscillatory motions as small as 10-100µ can induce wear and mechanically-assisted crevice corrosion (MACC). Such relative motion is unavoidable because modular junctions inherently introduce parts of different rigidity (size, shape) and different alloys (stiffness criteria). (Courtesy of Ian Clarke & Timothy McTighe)

Retrieved uncemented titanium alloy femoral stems with a modular cobalt-chromium (CoCr) head have been associated with crevice corrosion at the taper interface [6,7]. Dissimilar metals have a greater propensity for galvanic corrosion however studies have shown same metal alloys are also susceptible to taper corrosion. This supports the most likely mechanism behind corrosion at the head-neck interface being MACC rather than galvanism [8-10]. In certain combinations of high offset titanium alloy stem, with large CoCr heads, fretting and micro motion at the head-taper junction may result in additional factors leading to early implant failure (Image 2).

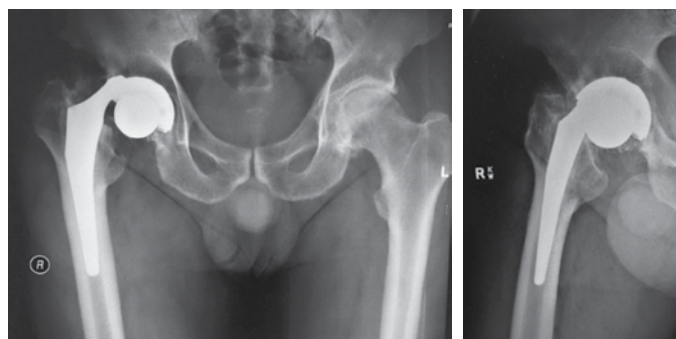
Image 3a and 3b: Patient 1 presenting anteroposterior and lateral radiographs dissociated head/neck taper junction of right total hip replacement.

Patient 1 was an active obese 76 year old male with a primary right THA implanted without complication over 7 years prior. He complained at presentation of 1-2 months of insidious right buttock pain which was activity related. The patient noted a sudden pain in the right groin and a leg length discrepancy while sitting on a chair. Acute radiographs in the emergency department showed an acute dissociation at the head-taper junction (Image 3).

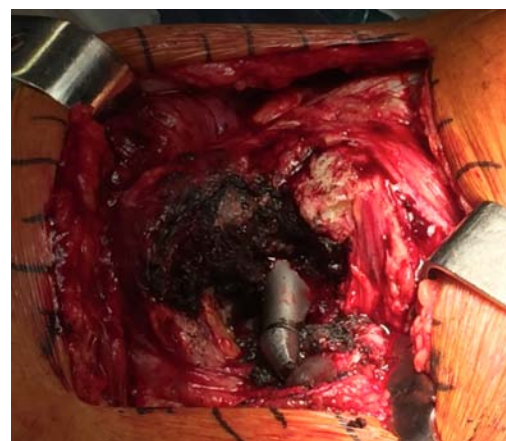
Image 4: Patient 1: Macroscopic appearance at revision of significant metallosis, dissociated neck taper junction, severe taper corrosion and gluteal muscle insufficiency.

Patient 1 underwent femoral stem revision through a standard posterior approach with flexible osteotomes. Significant metallosis was debrided (Image 4), and a modular distally fixed stem was implanted. Acetabular liner and head components were also replaced. The original acetabular shell was not affected and thus retained.

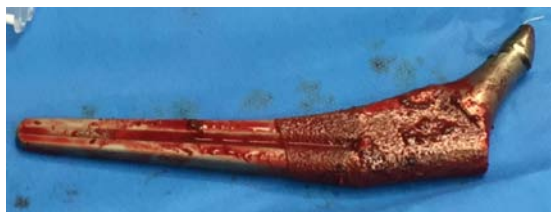
The retrieved femoral stem in Patient 1 showed severe taper corrosion as the cause of the spontaneous dissociation (Image 5). Histopathology confirmed significant metallosis with no sign of active or chronic inflammation.

Image 5: Patient 1: Retrieved femoral stem showing marked corrosion of the neck taper.

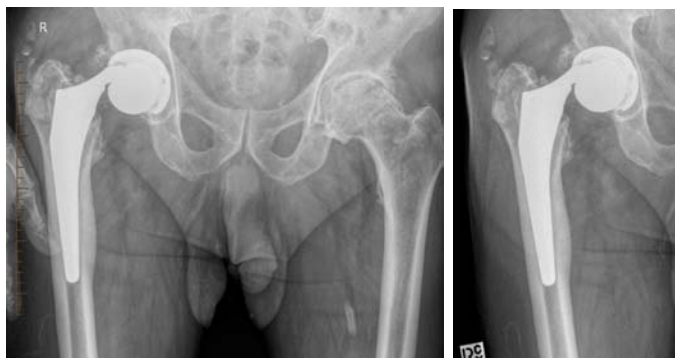
tation Patient 2 described an episode of spontaneous right buttock pain with a limp. Radiography of the right hip prior to the revision showed catastrophic failure of the trunnion with varus malalignment at the head-neck junction (Image 6).

Image 6a and 6b: Patient 2: Presenting anteroposterior radiographs showing prosthetic head/neck dissociation

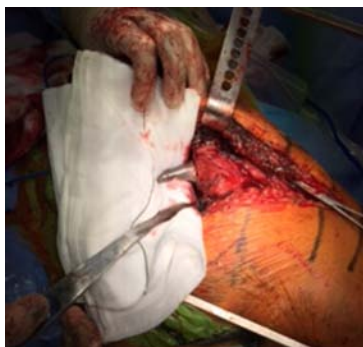
Image 7: Patient 2: Revision THA with metallosis, and significant neck taper corrosion.

Patient 2 underwent a revision THA with extended trochanteric osteotomy through a posterior approach. Metallosis surrounding the implant and gluteal muscles was debrided (Image 7) and components exchanged. Histopathology showed a moderate degree of chronic inflammation prosthesis detritus.

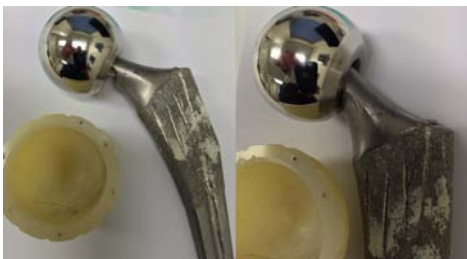
The retrieved femoral stem from Patient 2 revealed significant taper corrosion and instability of the head-neck junction with inferior notching of the neck from instability (Image 8). A modular distally fixed stem was successfully

Image 8: Patient 2: Retrieved femoral stem and acetabular liner with instability evident and dissociation of the head-neck junction.

implanted with a 32mm head.

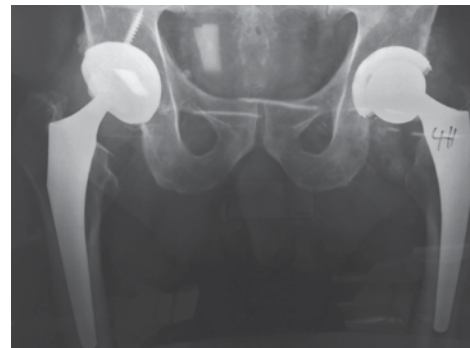
Patient 3 was a moderately active obese man who played golf weekly and had an uncomplicated primary left THA performed 4 years prior to presentation. Over one month he developed groin pain with symptoms worsening to a clicking feeling and sensation of instability. Patient 3 sustained a number of falls prior to revision of the left THA. Radiographs of the left THA revealed a varus dissociation of the neck taper junction (Image 9).

Image 9: Patient 3: Dissociation of the head-neck junction with varus malalignment.

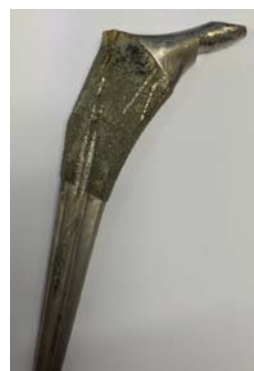
Patient 3 successfully underwent revision left THA through a posterior approach with an extended trochanteric osteotomy required for stem extraction. Significant metallosis was debrided at the time of surgery throughout the periarticular tissues. The retrieved femoral stem showed significant taper corrosion with notching of the inferior neck due to instability (Image 10).

Image 10: Patient 3: Retrieved femoral stem with marked neck taper corrosion and inferior notching.

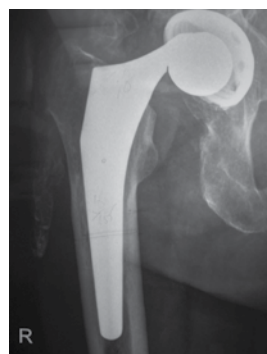
Patient 4 was a sedentary 80 year old man with multiple medical comorbidities. He underwent an uncomplicated primary right THA 7 years prior and presented with a sudden episode of unprovoked dislocation. Radiographs at presentation revealed a head-neck dissociation with abnormal wear evident on the taper (Image 11).

Image 11: Patient 4: Presenting anteroposterior radiograph of the dissociated head-neck junction of the right THA.

At revision of the right THA, metallosis was debrided and an isolated stem revision was successfully performed with a distally fixed prosthesis and exchange of the

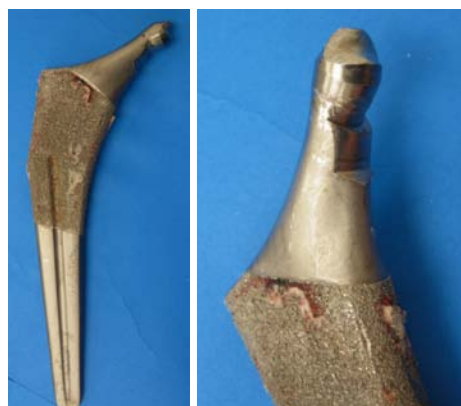
modular primary components. The retrieved femoral stem prosthesis had marked corrosion of the taper with inferior notching (Image 12).

Image 12a and 12b: Patient 4: Retrieved femoral stem prosthesis with taper corrosion evident and inferior neck notching.
