Modular Necks and Corrosion - Review of Five Cases

Abstract

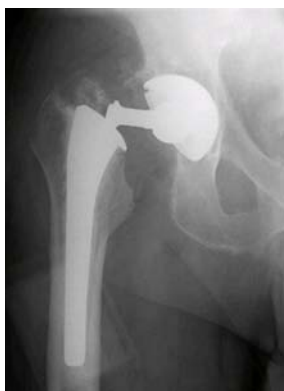
Figure 2. Fatigue Failure of C.C. modular neck used with a c.c. Cemented stem.(R-120™ Encore Orthopaedics) (Courtesy JISRF & H.U. Cameron)

Modern day designs (2000) have been used primarily in conventional cementless titanium alloy stems with either titanium alloy or cobalt-chromium (c.c.) modular necks. The issues that have plagued these modular neck designs have been fatigue failure of both titanium alloy, and c.c. along with fretting corrosion of the cobalt-chromium necks used with the titanium alloy stems [6,7]. Figure 2 & 3.

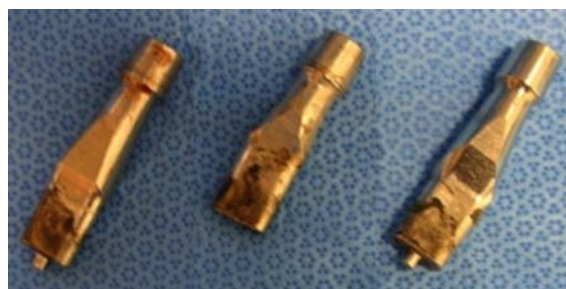
Figure 3. Retrieval of taper corrosion with dissimilar metals—cobalt-chrome alloy modular neck on titanium stem. (Courtesy WL Walter)

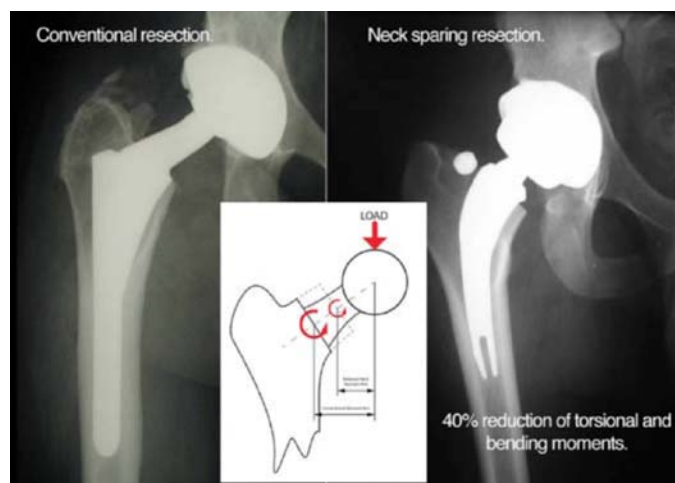
Figure 4. Two Postoperative X-rays showing different level neck resections and offsets resulting in less bending and torsional moments in the neck-sparing implant. (Courtesy of JISRF)

The use of modular necks in neck-preserving stem designs has had fewer problems in both areas of fatigue and fretting corrosion as compared to conventional neck resection stems.. The neck-preserving stem reduces both torsional and bending loads reducing the overall stress placed on the modular taper junction. [7,8,9] Figure 4.

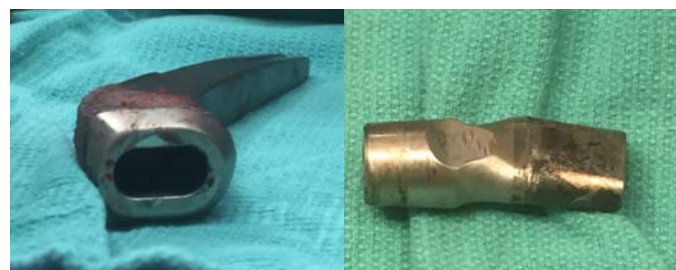
Figure 5. Explanted ARC stem 5 years post-op (Omni, Raynham MA.) Courtesy of B. Vaughn

The purpose of this commentary is to report our experience with a short curved neck-preserving cementless stem (titanium alloy) used with a modular neck junction of a different material (c.c.) resulting in suspected corrosion failure of the modular neck-stem junction. Figure 5.

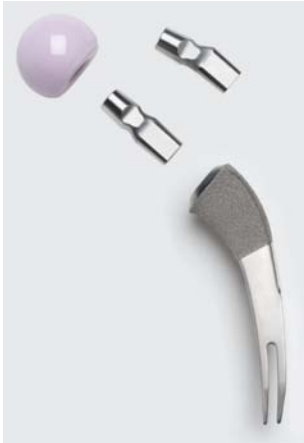
Figure 6. Omni ARC™ Stem (Omni, Raynham MA) Titanium Alloy Stem with HA and pure titanium plasma spray coating with a c.c. Modular neck.

This is a case series of five patients treated with primary cementless total hip arthroplasty (THA) between April 2010 and June 2016. Stem was the Omni ARC™ neck-sparing stem (titanium alloy stem with hydroxyapatite coating applied to the porous coating and a c.c. modular neck) Figure 6.

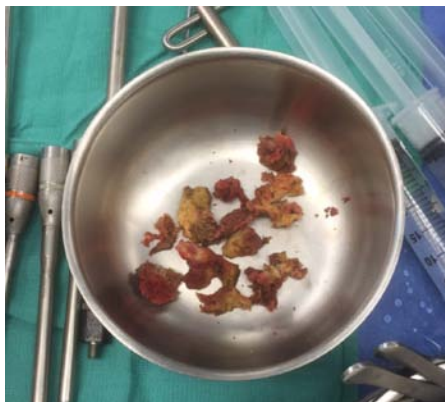
All stems were well fixed and revised by indexed surgeons to a contemporary cementless monoblock style stem. In all four cases there was minor discolored staining of implants and surrounding tissue. Figure 7

Figure 7. Tissue and bone debris showing slight staining from corrosion action of modular neck-stem taper. Courtesy of B. Vaughn

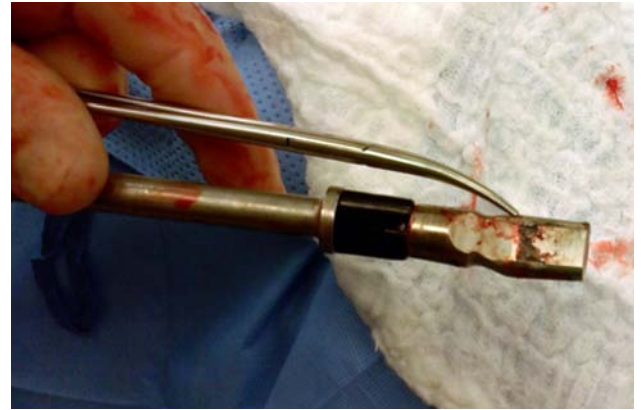
All femoral stems were well fixed with minor black staining of surrounding tissue and retrieved modular necks. Four of the modular necks were angled positions with one being neutral. Minor abnormal looking tissue was debrided with no abductor muscle necrosis observed. Figure 8

Figure 8. Extracted modular neck with black staining. Courtesy L. Keppler

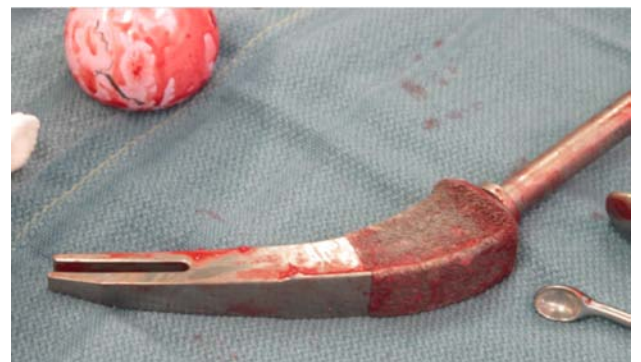
Material analysis was not preformed on the explanted devices. The neck-stem taper junction of each device was found to be well fixed with no signs of gross motion. Instrumentation allowed for ease of stem extraction with minor bone damage and conversion to a cementless primary stem length design. Figure 9.

Figure 9. Retrieval instruments allow for ease of extraction. Courtesy JISRF

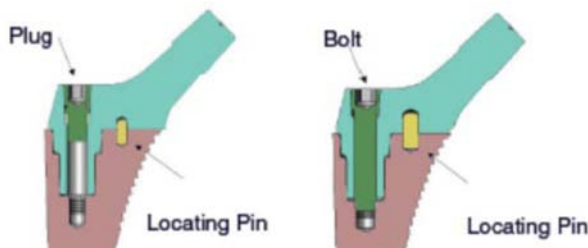
Figure 10. Illustration showing old Dual-Press design to new improved design increasing torsional resistance from 95 ft-lbs to 216 ft-lbs.

Ongoing research and testing on enhanced modular neck designs are demonstrating significant reduction in fretting abrasion debris and should be available in the near future. [1,8] We have also seen design improvements in two specific designs that have had identified clinical failure problems and have made design changes that to resolve those problems. [1,13] Figure 10 & 11

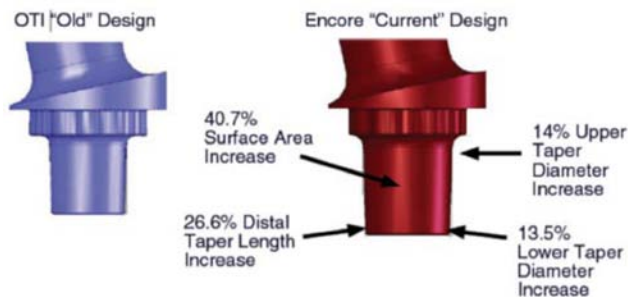
Figure 11. Illustration showing modular taper improvements from the original OTI™ design to the Encore improvement design. (Courtesy of JISRF)
