Modular Head Mismatch in THA

McTighe T¹

Keywords: modular head, mismatch, total hip arthroplasty

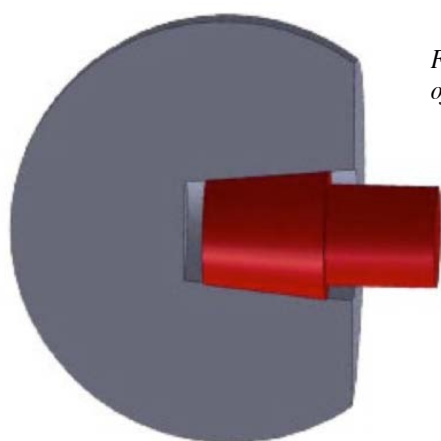
The success of a self-locking taper is influenced by the design of the taper, particularly the taper angle, the roughness, and the mating materials between the “male” and “female” components. This results in co-integration (locking), with material transfer across the zone of contact (cold welds). Figure 1.

Figure 1. Schematic of head/neck taper

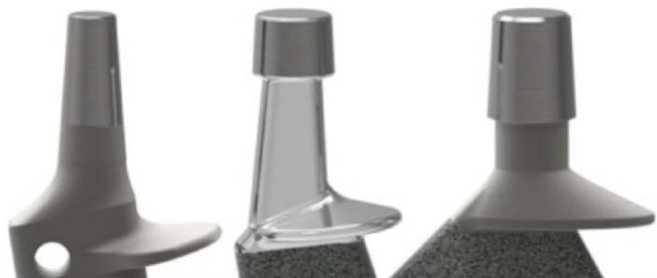
In the last two decades, manufactures have been altering femoral stem trunnions from various tapers such as 14/16 to 12/14 to 11/13. Figure 2. A range of different Morse taper angles, component tolerances and sizes, and surface finishes exist within commercially available hip systems. While manufacturers do not recommend mixing and matching of component brands, a number of surgeons have been mixing and matching without complications, provided the products used have the same manufacturing tolerances.

Figure 2. Illustration Showing Different Taper Designs by Manufacturers. (Courtesy Chris Burgess, Signature Orthopaedics Ltd.)

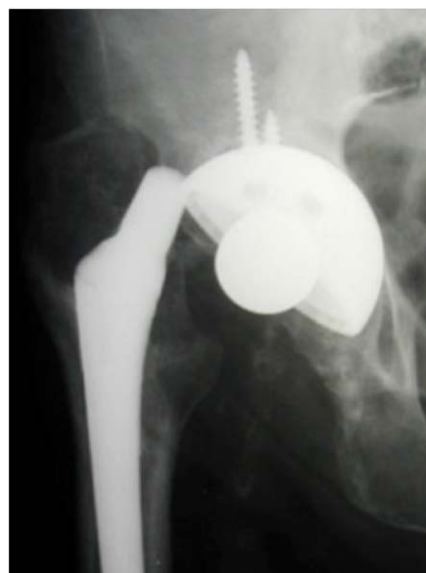
sociation of modular heads, incorrect head diameters implanted, and trunnion fatigue fractures. Figure 3.

Figure 3. Detachment of modular head can damage stem trunnion. (Curtsey JISRF Archives)

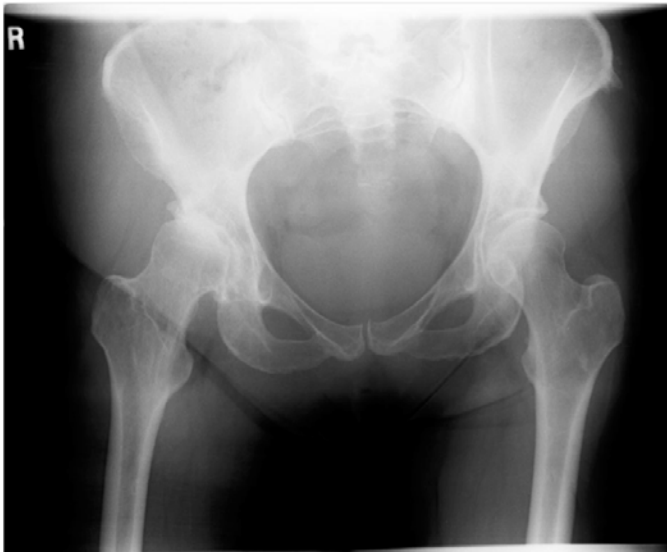
The patient presented for initial evaluation in her sixth decade with a recent history of progressive right hip pain, stiffness and difficulty with daily activities unresponsive to non-operative measures. On exam she had hip irritability with attempted range of motion and walked with a moderate limp. She had moderate hip stiffness. She had generalized ligamentous laxity. Radiographs showed advanced degenerative changes of the right hip with underlying right hip acetabular dysplasia. Figure 4.

Figure 4. Radiographs showed advanced degenerative changes of the right hip with underlying right hip acetabular dysplasia.

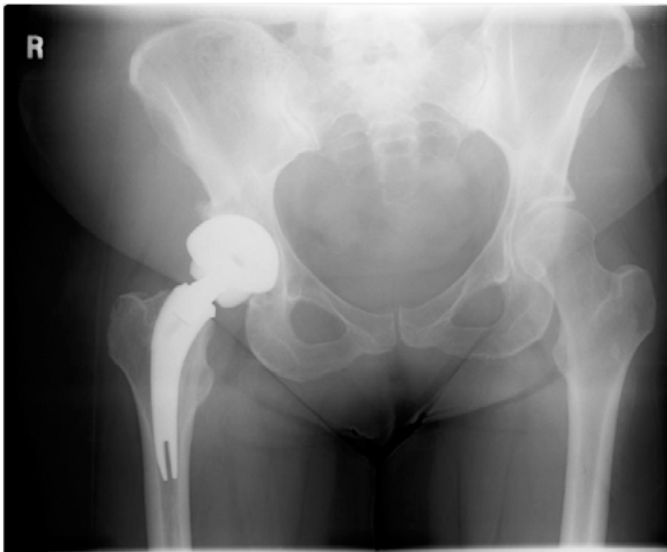
Figure 5. Mismatch head bearing diameter (36 mm ceramic head & 32 mm ceramic bearing liner)

She presented to the office for follow-up at three weeks with no difficulties. At eight weeks she reported a new grating sensation in the right hip without trauma. She had no significant pain and no complaints of a neurovascular nature. Radiograph revealed no evidence of ceramic fracture but a diameter mismatch of the femoral head and acetabular liner components. Review of the implant log revealed implantation of a 36 mm outside diameter head component with a 32 mm inside diameter acetabular liner. Figure 5.

She returned to the operating room for revision surgery which included acetabular liner exchange and exchange of the modular neck and femoral head component. The neck was replaced with identically sized implant. The femoral head component was changed to a 32 mm outside diameter medium length alumina ceramic head. This combination

maintained leg length and provided good stability. Again, she had an uneventful postoperative course. Acetabular shell and femoral stem components were noted to be well fixed and well positioned.

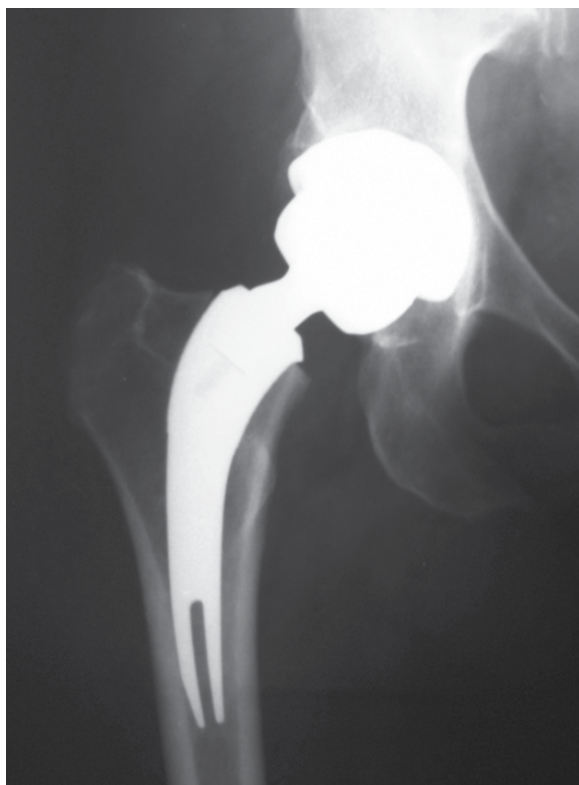
She presented to the office at 2 weeks having transitioned to a cane at one week. She presented at 6 weeks complaining of mild persistent pain. Radiograph revealed no evidence of ceramic fracture. Component position was felt to be excellent but a diameter mismatch of the femoral head and acetabular liner was suspected due to subtle asymmetry of the head and acetabula shell. Review of the implant log revealed implantation of a 40 mm outside diameter head component with a 36 mm inside diameter acetabula liner. Figure 6.

Figure 6. Mismatch head bearing diameter (40 mm head & 36 mm bearing liner)

She returned to the operating room for revision. Acetabular shell and femoral stem components were noted to be well fixed and well positioned. The femoral head component was changed to a 36-+4-alumina ceramic. The modular neck and polyethylene liner were retained. This combination maintained good leg length and provided good stability. Again, she had an uneventful postoperative course.
