# “Within Any Important Issue, There Are Always Aspects No One Wishes To Discuss” – Femoral Component Failure

Keggi, K.<sup>1</sup>, Keggi, J.<sup>1</sup>, Kennon, R.<sup>1</sup>, Tkach, T.<sup>2</sup>, Low, W.<sup>2</sup>, Froehlich, J.<sup>3</sup>, McTighe, T.<sup>4</sup>, Cheal, E.<sup>5</sup>, Cipolletti, G.<sup>5</sup>

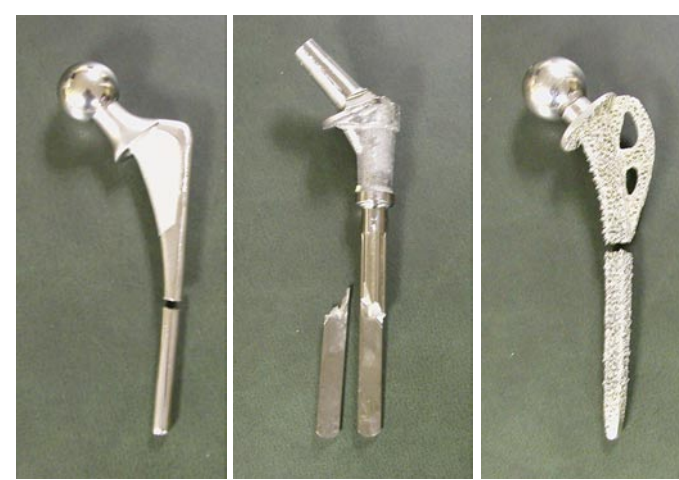
Fx, c.c. cemented Fx, Bridge™ Titanium Cemented Fx, c.c. cementless

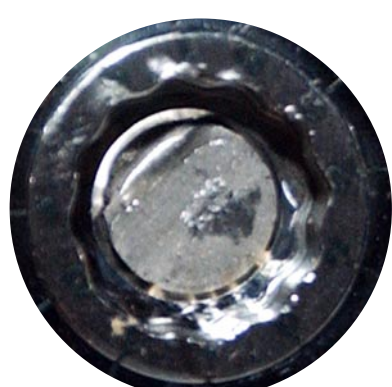
Fatigue failure c.c. modular neck.

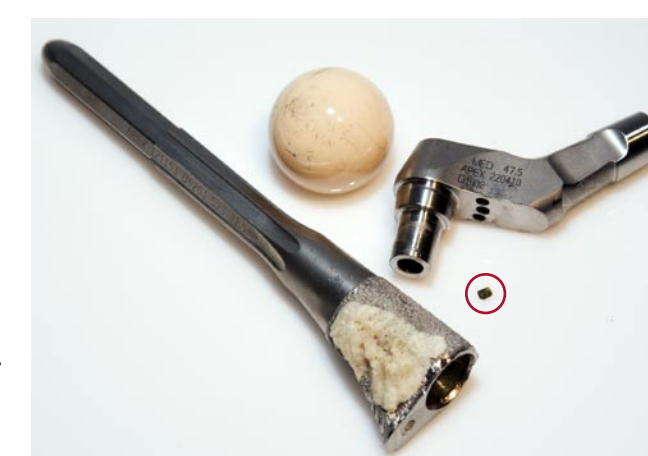
Surgical intervention found locking pin to be sheared with rotational instability of the proximal neck and black staining of tissue due to metal debris. Twenty-one stems have been revised with standard length cementless stems of a variety of designs. All have gone on to full recovery. One patient is not a surgical candidate and is not experiencing any significant pain.

No material or fabrication defects were found. No surgical errors were found. Mechanical testing demonstrated safety levels to be beyond published activity loads. The culprit (in most cases) appears to be patient activity.

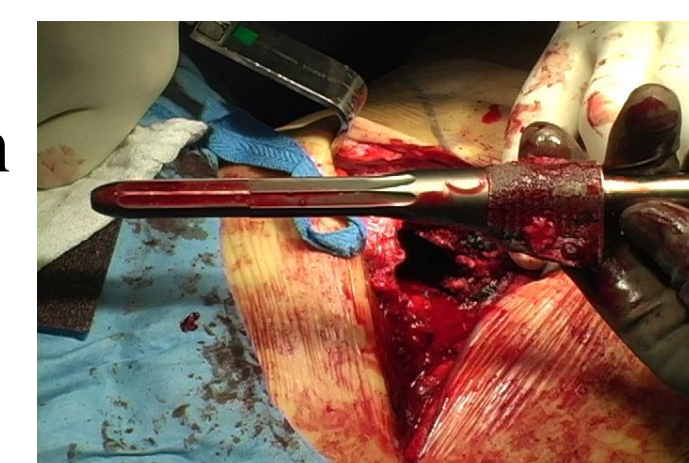
Retrieved stem.

Components are designed with an axial extraction feature that facilitates removal. This allows preservation of proximal bone stock for re-implantation.
